CoA Memo Aero No. 58

December, 1964

THE COLLEGE OF AERONAUTICS
DEPARTMENT OF AIRCRAFT DESIGN

Structural testing of wooden aircraft

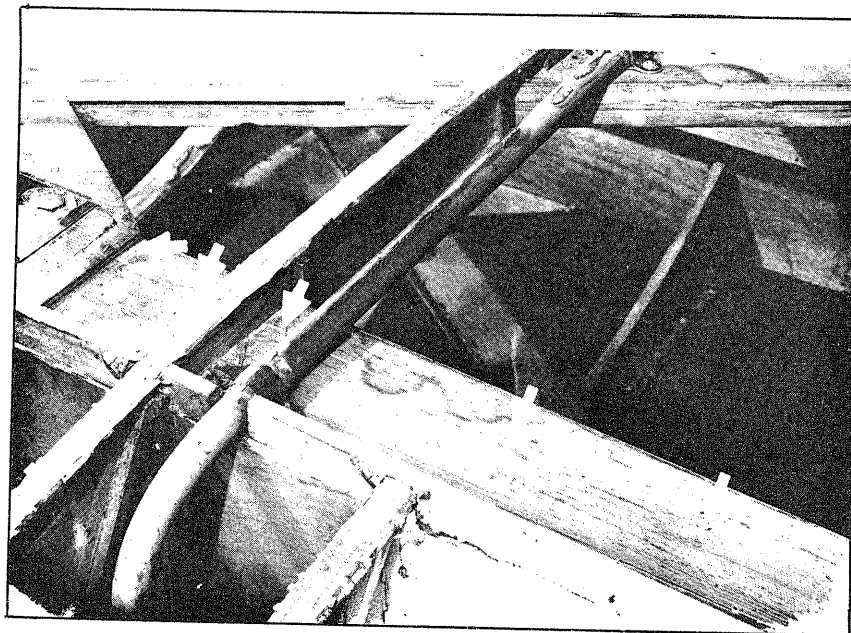
All Proctor wing spar failures occurred at the root joint connection, and were bearing failures in the front spar booms. Ultimate strength of the wings was within the range 88 per cent to 94 per cent F.F.L.

FIG. 6. TYPICAL LOWER BOOM FRONT SPAR FAILURE - PROCTOR OUTER WING.

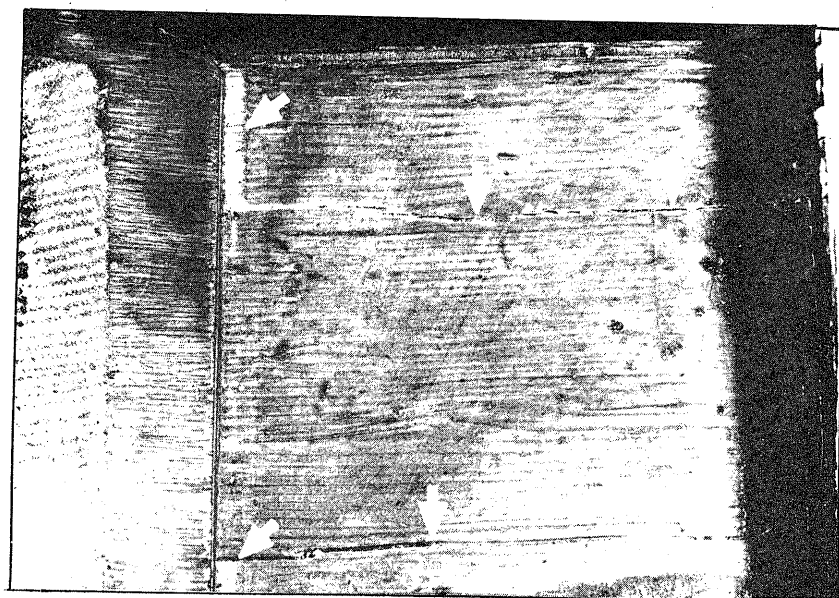
FIG. 7. CLOSE UP OF BOOM FAILURE OUTBOARD OF OUTER WING ATTACHMENT BRACKET. PROCTOR.

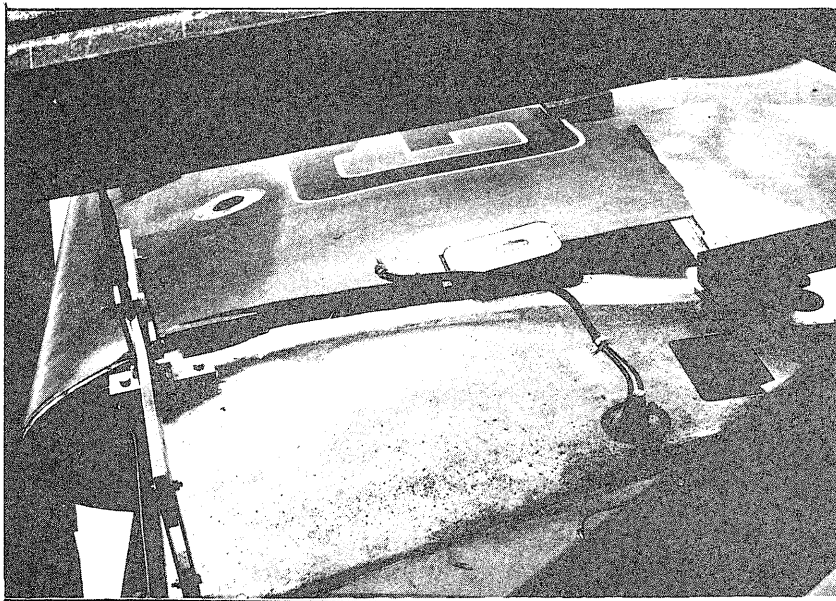
All Gemini wing skin cracks referred to in table 1 (with the exception of the leading edge of G-AMGF - test number 14) occurred at the corner of the handhole hinge cut-out and were propagated from that point at relatively low percentage fully factored load. The cracks were, without exception, of considerable size, i.e. a minimum length split in the plywood of approximately 6", the plywood being completely ruptured over the length of the split, and easily recognisable. The original RF (minimum) for the wings was 1.0 (100 per cent F.F.L.).

FIG. 8. PORT WING TOTAL FAILURE. GEMINI G-AJWC.
SHOWING TYPICAL POSITION OF SKIN SPLIT
(INITIAL FAILURE).

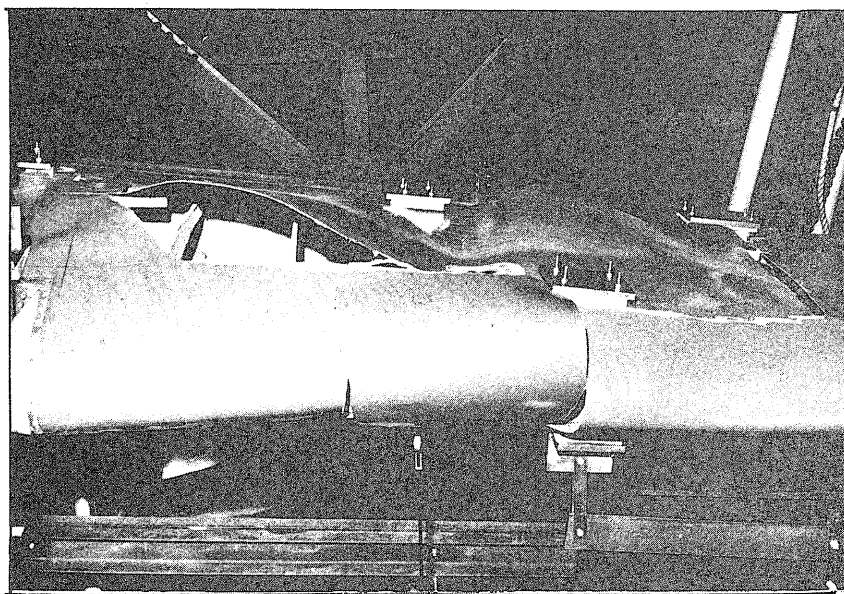
FIG. 9. GEMINI G-AJWC. STARBOARD WING. TOTAL FAILURE
OF BOTH SPARS AND WING STRUCTURE.

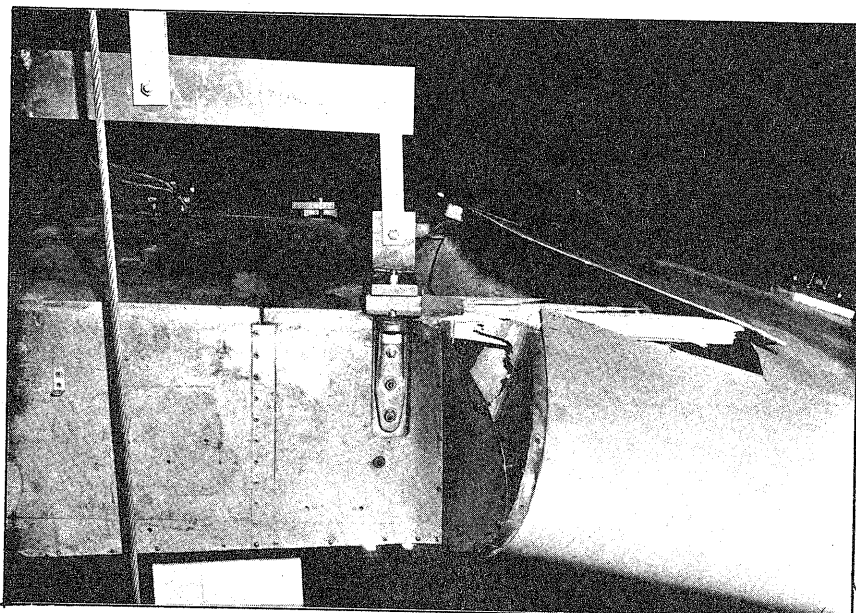
FIG. 10. TOTAL FAILURE POSITION, JUST OUTBOARD OF ENGINE ATTACHMENT BRACKET. GEMINI G-AJWF (STARBOARD WING).

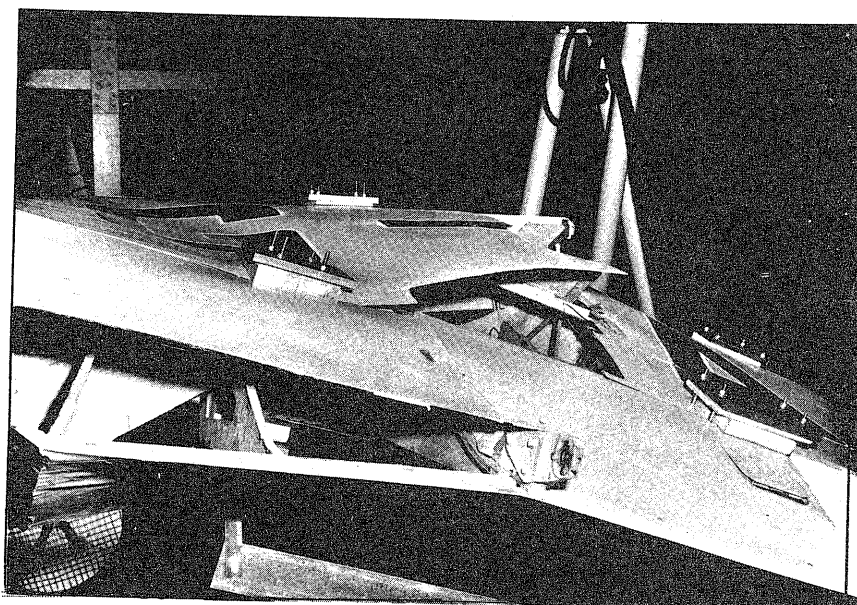
FIG. 11. TOTAL COLLAPSE OF PORT WING GEMINI G-AJWF.

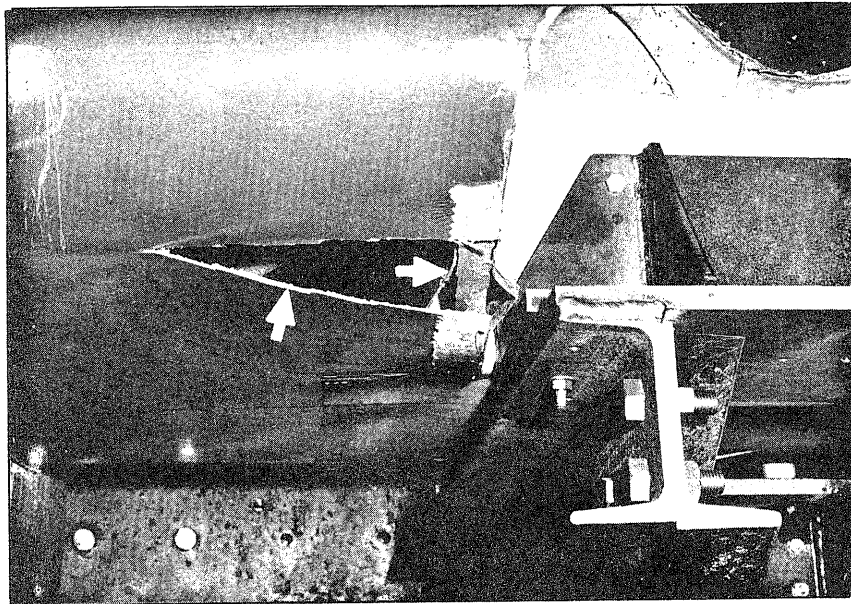
In the case of one Gemini tailplane (test number 10), the applied load at skin joint failure was 115 per cent of the fully factored load. This was the only glue failure of the series, and is a significantly lower figure than those obtained for the other two tailplanes, which exceeded 181 per cent and 146 per cent F.F.L. respectively. The type record calculated factor is 1.0 minimum, i.e. 100 per cent F.F.L.

FIG. 12. SKIN SPLIT AND GLUE JOINT FAILURE AT THE ROOT, GEMINI G-AJWC TAILPLANE.

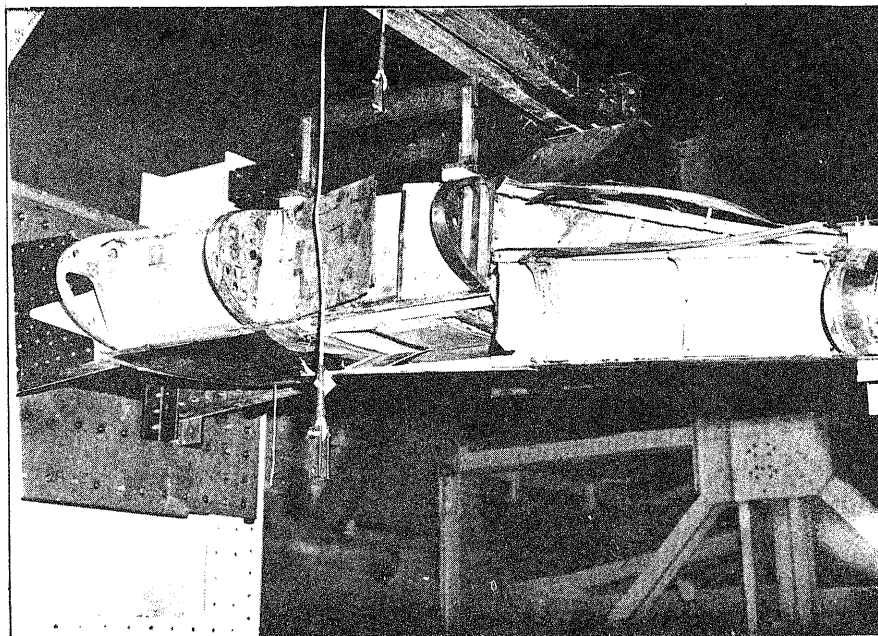
FIG. 13. TYPICAL COLLAPSE OF STARBOARD WING, GEMINI MK. VII G-AMGF.

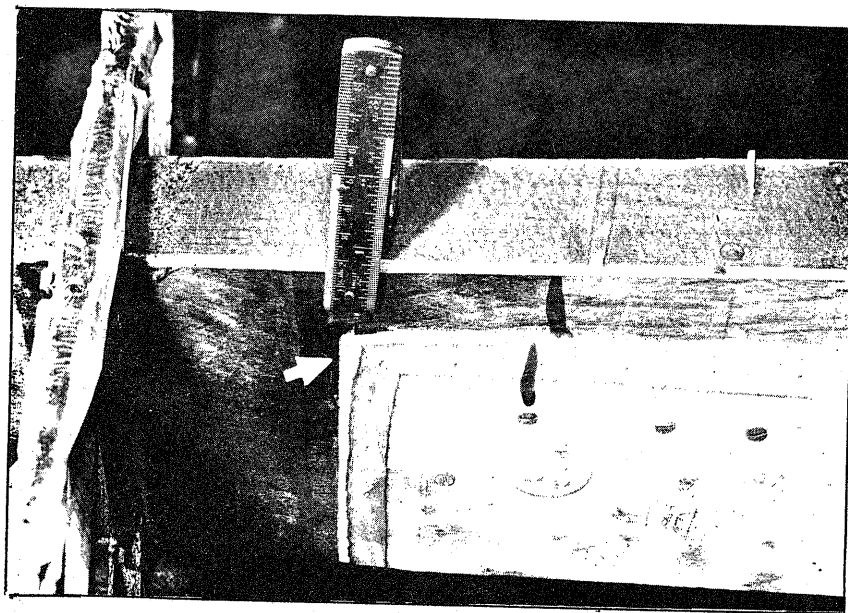
FIG. 14. DEFECT. PROCTOR PORT WING. G-AHBA.
INSPECTION PANEL LIFTING AT CORNERS.

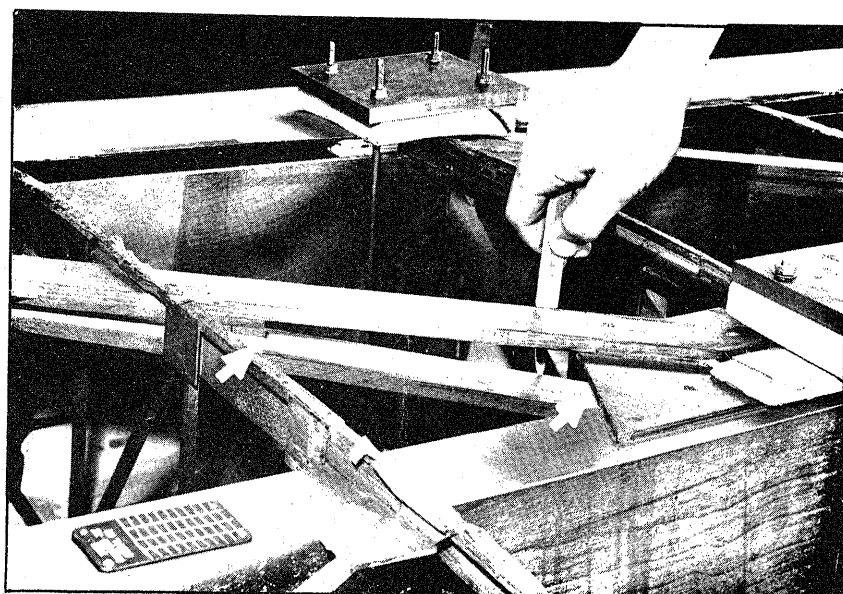
FIG. 15. DEFECT. SAME WING SECTION AS FIG. 14. DRAG
BRACE TOTAL GLUE JOINT FAILURE.

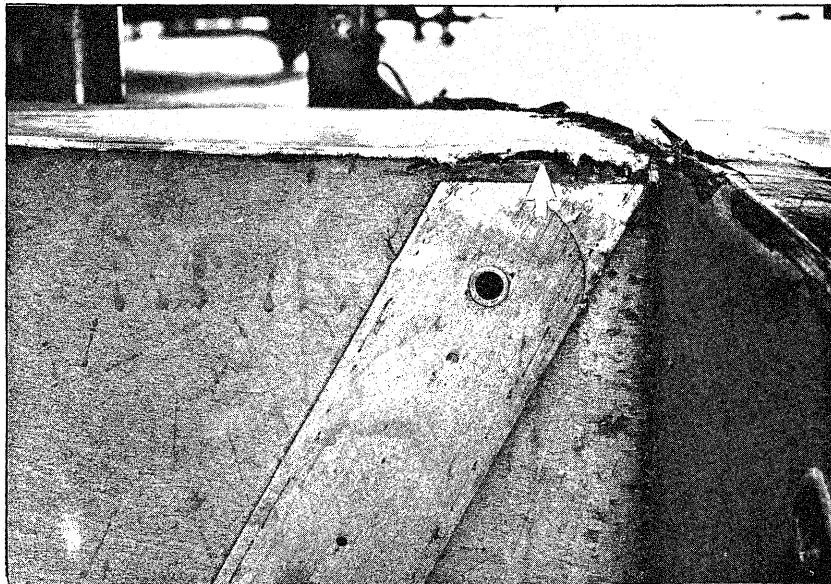
FIG. 16. GEMINI G-AJWC. SKIN LIFTING AT CENTRE SECTION OF TAILPLANE.

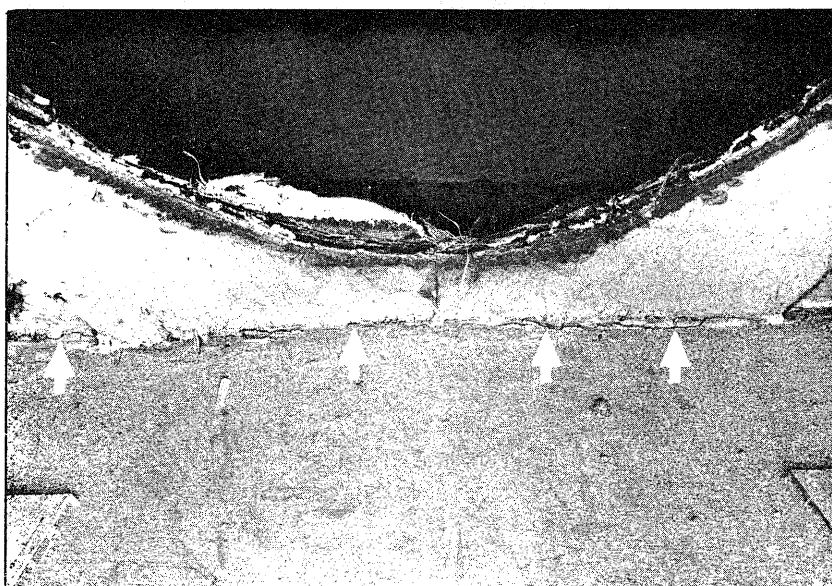
FIG. 17. DIAPHRAGM/TOP SKIN GLUE FAILURE. GEMINI G-AJWC TAILPLANE.

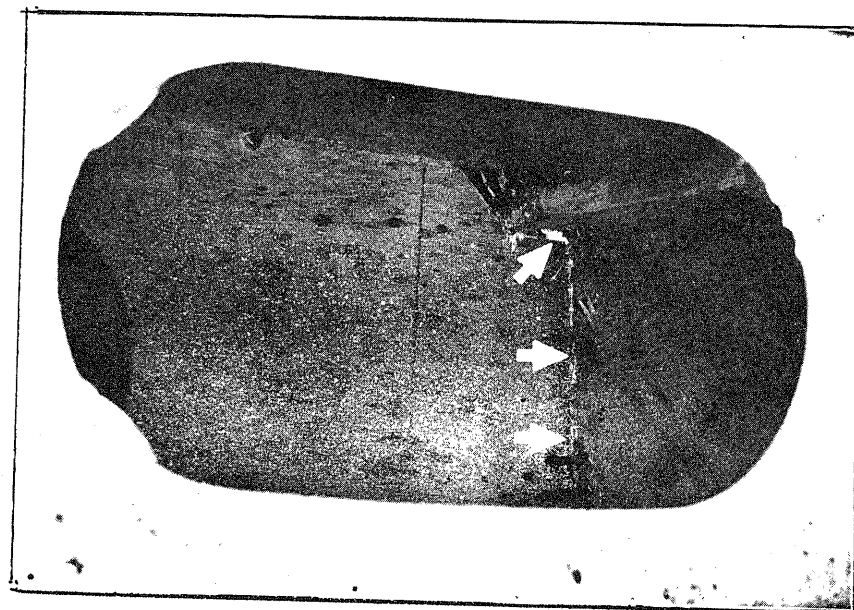
FIG. 18. SPAR/OUTBOARD GLUE FAILURE VIEWED THROUGH THE TIP RIB. GEMINI G-AJWC.
